**Flood Control Project Maintenance
Levee Inspections**

Fall 2015 Levee Maintenance Deficiency Summary Report

Sacramento River Basin

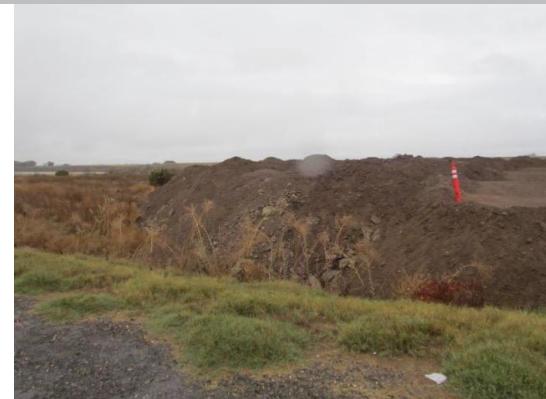
Photo 1 of 3 : FA_2015_RD0999_232_1_20151106_00086.jpg

LM Start	0.12	Rating **	U	Issue No.	1										
LM End	0.39	Issue Type +	En	Location *	WS										
Category	Earthen Levee		GPS Latitude/Longitude												
			Start	End											
Item	Encroachments		38.503346 °	38.499389 °											
			-121.582116 °	-121.581933 °											
DWR ID	DWR_RD0999_01_s_2012_1														
Action/Comments															
Material Inspector Comments: Landfill has been in place for several years. Landowner is hauling additional material on waterward berm.

Looking west at the end of new fill on waterward berm fall 2015.

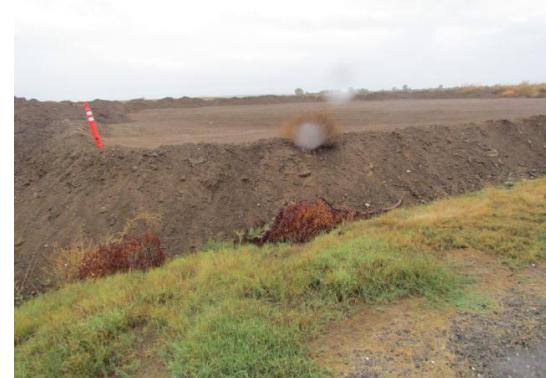
Photo 2 of 3 : FA_2015_RD0999_232_1_20151106_00087.jpg

Looking west at new fill on waterward berm fall 2015.

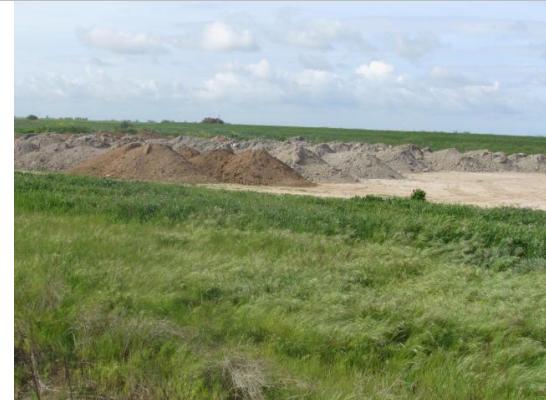
Photo 3 of 3 : FA_2015_RD0999_232_1_20150914_00001.jpg

Looking west at new material on waterward berm.

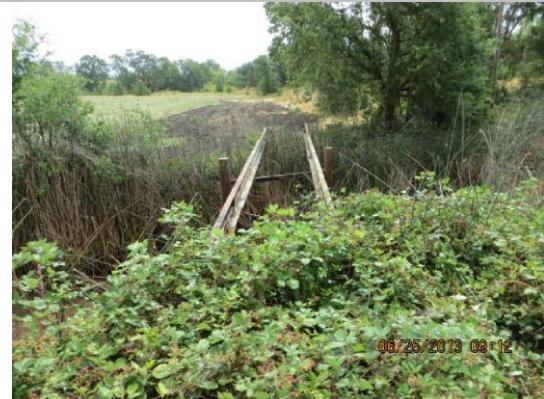
Photo 2 of 3 : UCIP_FA_2015_1290.jpg

LM Start	1.72	Rating **	U	Issue No.	921 (cont)									
LM End	1.72	Issue Type +	En	Location *	LS									
Category	Supplemental			GPS Latitude/Longitude										
				Start	End									
Item	DWR UCIP Field Study			38.480097 °	38.480097 °									
				-121.580844 °	-121.580844 °									
DWR ID														
Action/Comments														
Inspector Comments: FS_ID:39764 DS_ID:22743 EP_NO: N/A FS_HLM: 1.742 Repair Type: Urgent Crossing Status: Found UCIP Comments: Pipe abandoned and open on WS slope. Pipe should be abandoned properly. FIELD_STRUCT_DESC: 30-inch pipe through levee 6.5 feet below crown. Pump missing from platform in canal off LS toe. Flap gate on the waterward end. Siphon breaker and air vent on the landward shoulder. 1-inch galvanized iron filler pipe visible at WS shoulder along same alignment. Originally included in the 1966 O&M manual. FS Date: 06/25/2013

Pump platform visible off LS toe, but no appurtenances remain.

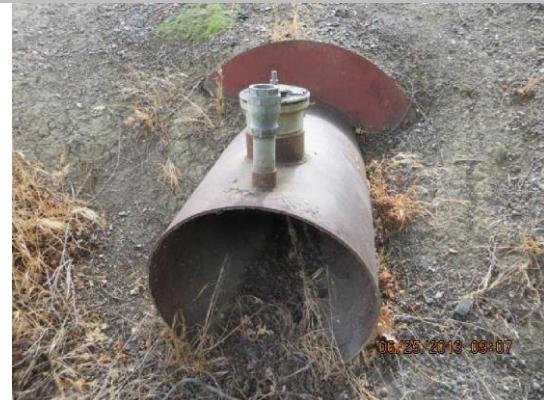
Photo 3 of 3 : UCIP_FA_2015_1291.jpg

Pipe open on WS slope

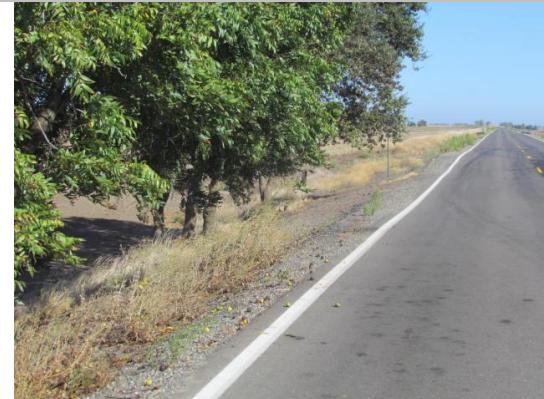
Photo 1 of 2 : FA_2015_RD0999_232_4_20150914_00008.jpg

Looking northwest at trimmed trees on waterward slope.

LM Start	1.73	Rating **	M	Issue No.	4										
LM End	1.75	Issue Type +	Ma	Location *	WS										
Category	Earthen Levee			GPS Latitude/Longitude											
				Start	End										
Item	Trim / Thin Trees			38.480082 °	38.479788 °										
				-121.580930 °	-121.580918 °										
DWR ID	DWR_RD0999_01_s_2012_4														
Action/Comments															
Trim trees to at least five feet above ground level.

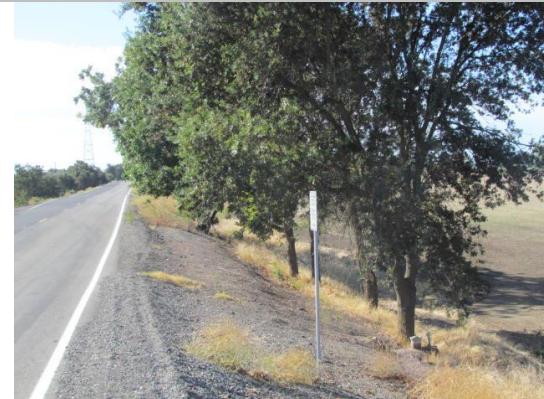
Photo 2 of 2 : FA_2015_RD0999_232_4_20150914_00009.jpg

Looking southwest at trimmed trees on waterward slope.

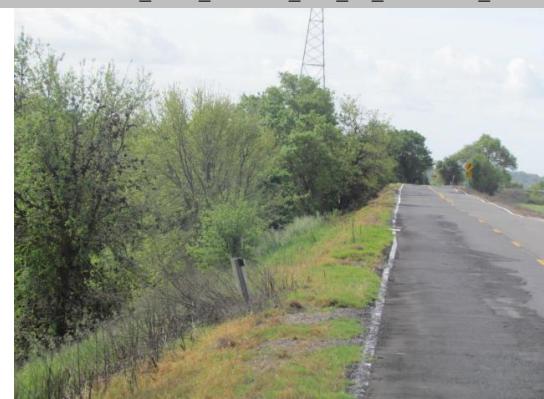
Photo 1 of 5 : FA_2015_RD0999_232_30_20150914_00034.jpg

Looking southeast at untrimmed trees on landward slope. (Spring 2015)

LM Start	1.79	Rating **	M	Issue No.	30										
LM End	2.04	Issue Type +	Ma	Location *	LS										
Category	Earthen Levee			GPS Latitude/Longitude											
				Start	End										
Item	Trim / Thin Trees			38.479165 °	38.475463 °										
				-121.580640 °	-121.580722 °										
DWR ID	DWR_RD0999_01_s_2012_30														
Action/Comments															
Trim trees to at least five feet above ground level.

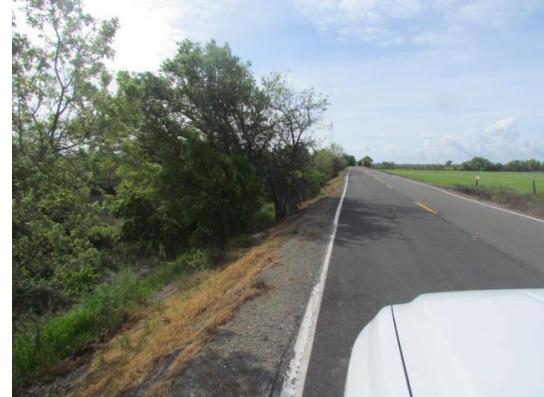
Photo 2 of 5 : FA_2015_RD0999_232_30_20150914_00035.jpg

Looking southeast at dense trees on landwater slope. (Spring 2015)

LM Start	1.79	Rating **	M	Issue No.	30 (cont)							
LM End	2.04	Issue Type +	Ma	Location *	LS							
Category			Earthen Levee			GPS Latitude/Longitude						
					Start	End						
Item	Trim / Thin Trees			38.479165 °	38.475463 °							
				-121.580640 °	-121.580722 °							
DWR ID	DWR_RD0999_01_s_2012_30											
Action/Comments												
Trim trees to at least five feet above ground level.

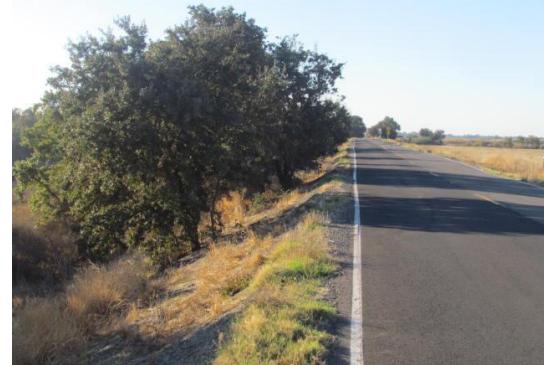
Photo 3 of 5 : FA_2015_RD0999_232_30_20150914_00036.jpg

Looking south at typical view of untrimmed trees on landward slope.

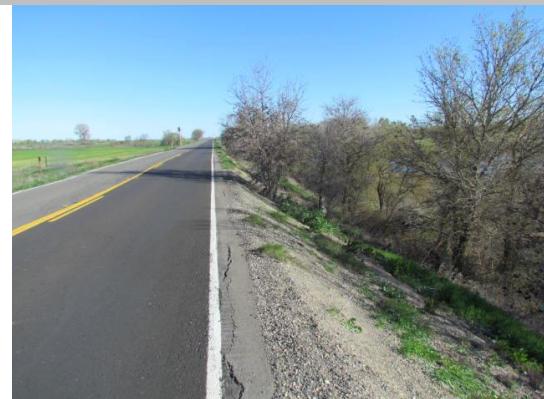
Photo 4 of 5 : FA_2015_RD0999_232_30_20150914_00037.jpg

Looking north at several untrimmed trees on landside slope.

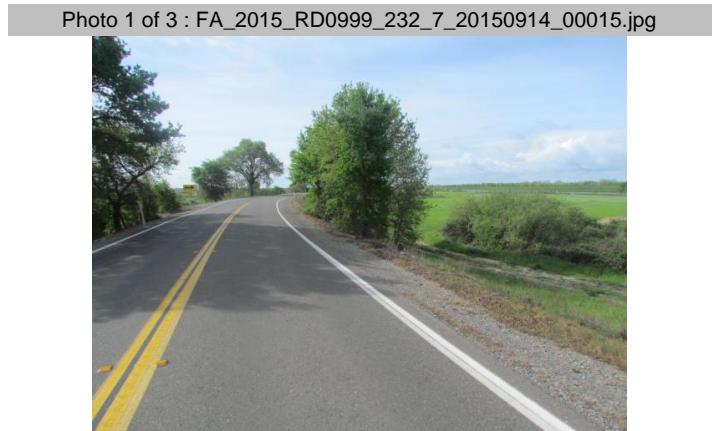
Looking south at untrimmed trees on waterward slope. (Spring 2015)

LM Start	2.13	Rating **	U	Issue No.	7									
LM End	2.13	Issue Type +	Ma	Location *	WS									
Category	Earthen Levee			GPS Latitude/Longitude										
				Start	End									
Item	Trim / Thin Trees			38.474258 °	38.474258 °									
				-121.580528 °	-121.580528 °									
DWR ID	DWR_RD0999_01_s_2012_7													
Action/Comments														
Trim trees to at least five feet above ground level.

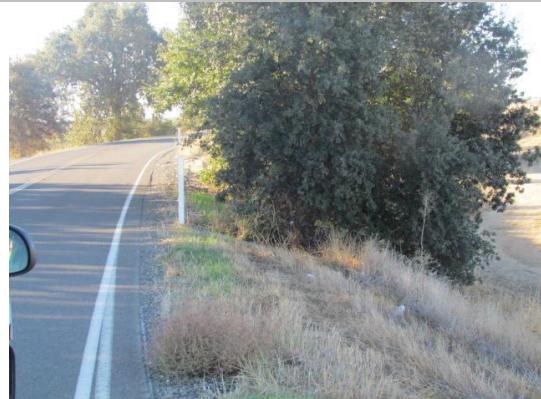
Photo 2 of 3 : FA_2015_RD0999_232_7_20150914_00016.jpg

Looking south at untrimmed trees on waterward slope. (Fall 2014)

LM Start	2.13	Rating **	U	Issue No.	7 (cont)	
LM End	2.13	Issue Type +	Ma	Location *	WS	
Category	Earthen Levee			GPS Latitude/Longitude		
Item	Trim / Thin Trees			Start	End	
DWR ID	DWR_RD0999_01_s_2012_7			38.474258 °	38.474258 °	
Action/Comments						
Trim trees to at least five feet above ground level.

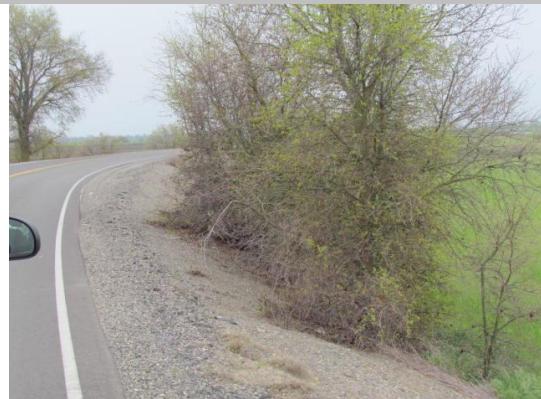
Photo 3 of 3 : FA_2015_RD0999_232_7_20150914_00017.jpg

Looking southwest at untrimmed trees on waterside slope.

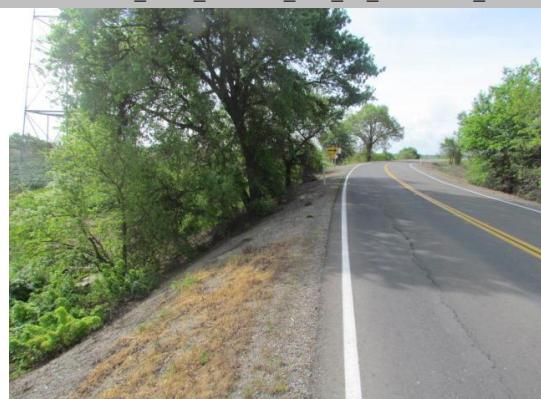
Photo 1 of 3 : FA_2015_RD0999_232_31_20150914_00039.jpg

Looking southeast at untrimmed trees on landward slope. (Spring 2015)

LM Start	2.13	Rating **	U	Issue No.	31	
LM End	2.13	Issue Type +	Ma	Location *	LS	
Category	Earthen Levee			GPS Latitude/Longitude		
Item	Trim / Thin Trees			Start	End	
DWR ID	DWR_RD0999_01_s_2012_31			38.474200 °	38.474200 °	
Action/Comments						
Trim trees to at least five feet above ground level.

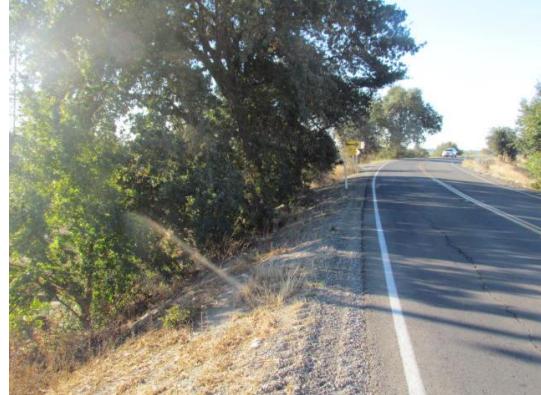
Photo 2 of 3 : FA_2015_RD0999_232_31_20150914_00040.jpg

Looking southeast at untrimmed trees on landward slope. (Fall 2014)

LM Start	2.13	Rating **	U	Issue No.	31 (cont)	
LM End	2.13	Issue Type +	Ma	Location *	LS	
Category	Earthen Levee			GPS Latitude/Longitude		
Item	Trim / Thin Trees			Start	End	
DWR ID	DWR_RD0999_01_s_2012_31			38.474200 °	38.474200 °	
Action/Comments						
Trim trees to at least five feet above ground level.

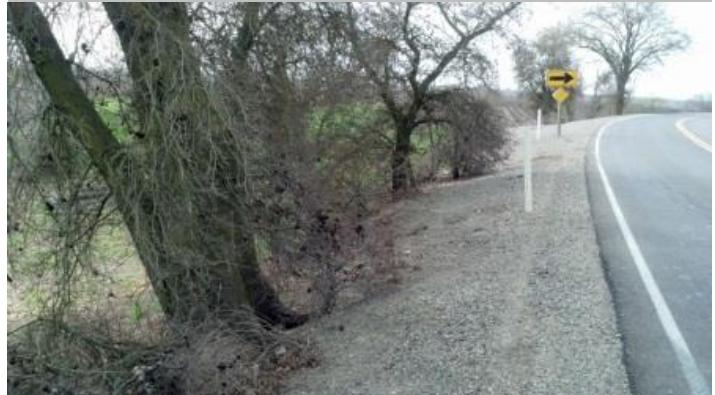
Photo 3 of 3 : FA_2015_RD0999_232_31_20150914_00041.jpg

Looking southeast at untrimmed trees on landside slope.

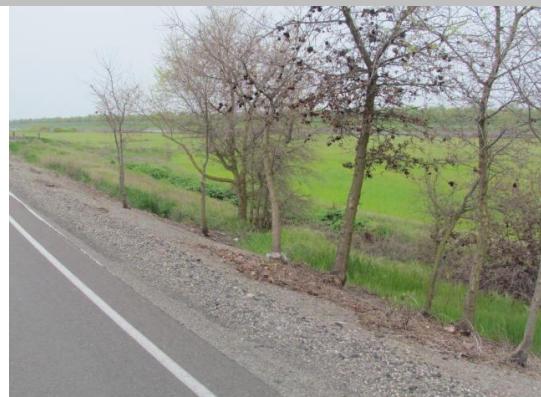
Photo 1 of 1 : FA_2015_RD0999_232_8_20150914_00018.jpg

Looking southwest at trimmed trees on waterside slope. (Spring 2012)

LM Start	2.18	Rating **	M	Issue No.	8	
LM End	2.19	Issue Type +	Ma	Location *	WS	
Category	Earthen Levee			GPS Latitude/Longitude		
Item	Trim / Thin Trees			Start	End	
DWR ID	DWR_RD0999_01_s_2012_8			38.473542 °	38.473417 °	
Action/Comments						
Thin trees to allow visibility of the ground and room to flood fight.

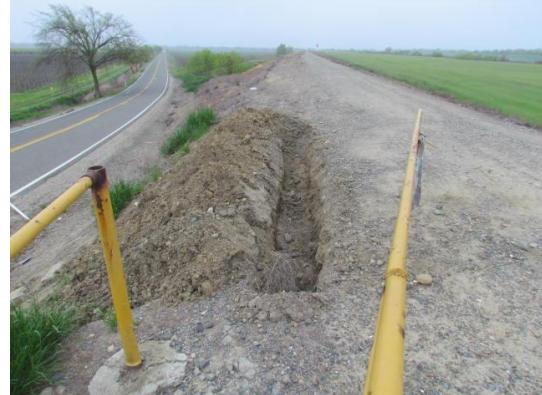
Photo 1 of 3 : FA_2015_RD0999_232_40_20150914_00049.jpg

LM Start	2.51	Rating **	M	Issue No.	40										
LM End	2.51	Issue Type +	Ma	Location *	LS										
Category	Earthen Levee		GPS Latitude/Longitude												
			Start	End											
Item	Encroachments		38.469048 °	38.469048 °											
			-121.583075 °	-121.583075 °											
DWR ID	DWR_RD0999_01_s_2012_40														
Action/Comments															
Material Inspector Comments: Excavation activity on landside shoulder. Hole is approximately 15ft x 12" x 15". Hole appears to be excavated by a backhoe.

Looking south at excavation with backhoe on landside shoulder.

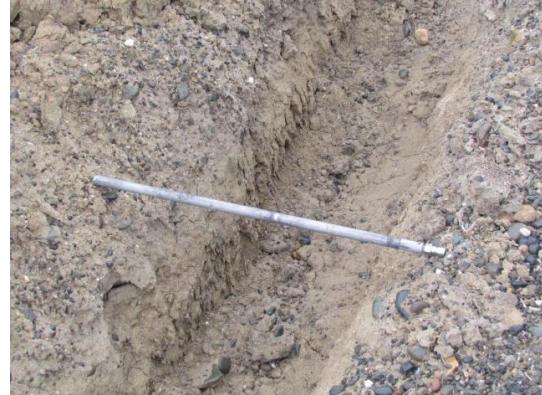
Photo 2 of 3 : FA_2015_RD0999_232_40_20150914_00050.jpg

Looking south at close-up view of excavation on landside shoulder.

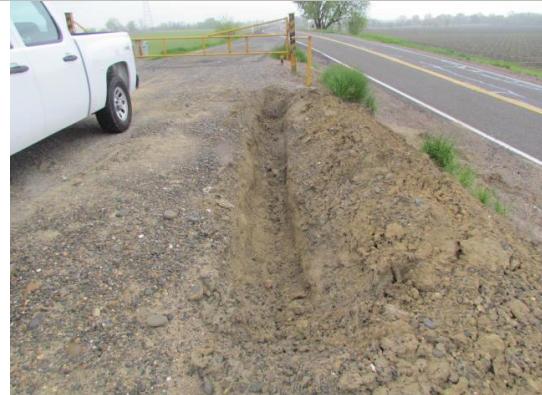
Photo 3 of 3 : FA_2015_RD0999_232_40_20150914_00051.jpg

Looking north at excavation on landside shoulder.

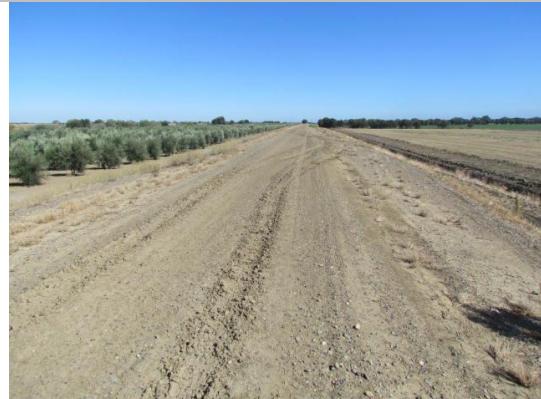
Photo 1 of 3 : FA_2015_RD0999_232_46_20150914_00056.jpg

Looking north at rutting on levee crown.

LM Start	2.76	Rating **	A/W	Issue No.	46													
LM End	4.98	Issue Type +	Ma	Location *	CR													
Category	Earthen Levee			GPS Latitude/Longitude														
				Start	End													
Item	Crown Surface / Depressions / Rutting			38.465627 °	38.435378 °													
DWR ID	DWR_RD0999_01_f_2013_46																	
Action/Comments																		
Repair depressions or ruts in the crown or slope. Inspector Comments: Control growth on levee crown and repair ruts on levee crown.

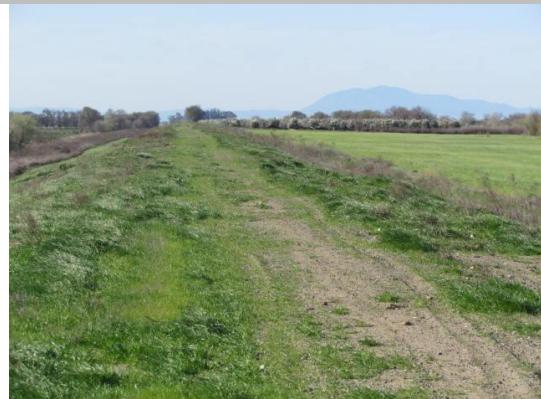
Photo 2 of 3 : FA_2015_RD0999_232_46_20150914_00057.jpg

Looking south at growth and ruts on levee crown.

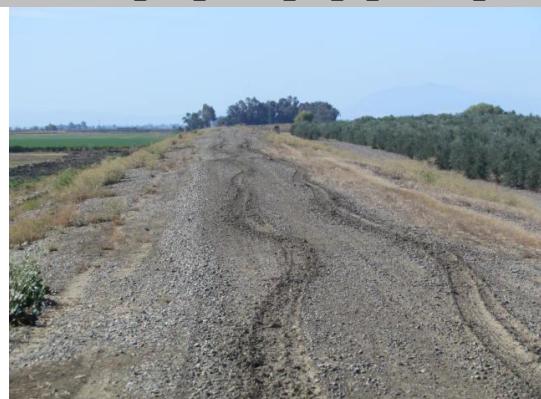
Photo 3 of 3 : FA_2015_RD0999_232_46_20150914_00058.jpg

Looking south at rutting on levee crown.

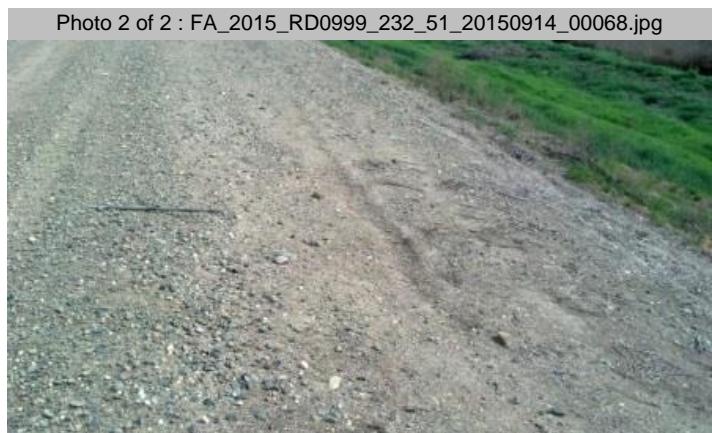
LM Start	3.24	Rating **	M	Issue No.	51													
LM End	3.26	Issue Type +	Ma	Location *	LS													
Category	Earthen Levee			GPS Latitude/Longitude														
				Start	End													
Item	Slope Stability				°		°		°									
DWR ID	DWR_RD0999_01_s_2013_51																	
Action/Comments																		
Repair slope instability. Inspector Comments: Depression on waterside shoulder and slope 60' x 20'. Earthen material appears to be sliding toward levee toe.

Looking northeast at depression on landside shoulder.

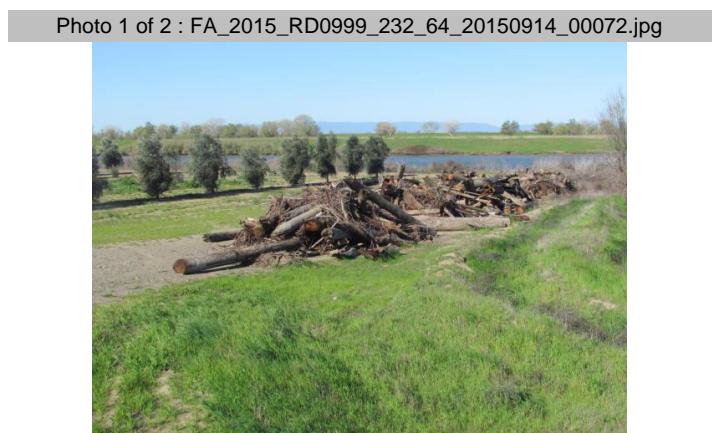
LM Start	3.30	Rating **	M	Issue No.	64													
LM End	3.30	Issue Type +	En	Location *	WS													
Category	Earthen Levee			GPS Latitude/Longitude														
				Start	End													
Item	Encroachments			38.458346 °	38.458346 °													
				-121.588008 °	-121.588008 °													
DWR ID	DWR_RD0999_01_s_2014_64																	
Action/Comments																		
Tree or limb Inspector Comments: Discarded tree branches, limbs and power poles stockpile on waterward berm.

Looking southwest at pruning on waterward berm.

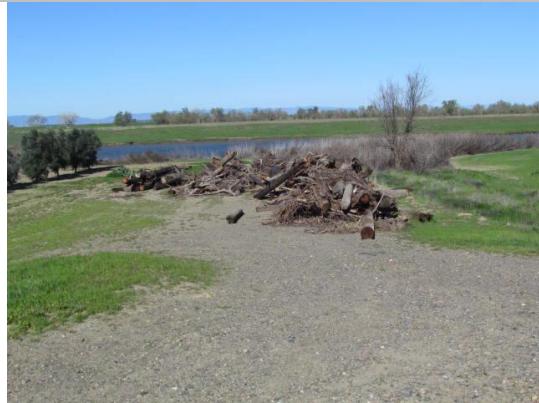
Photo 2 of 2 : FA_2015_RD0999_232_64_20150914_00073.jpg

Looking west at prunings on waterward berm.

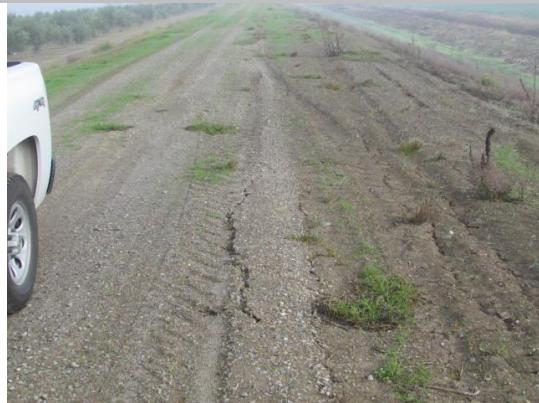
Photo 1 of 2 : FA_2015_RD0999_232_6_20150914_00013.jpg

LM Start	3.62	Rating **	M	Issue No.	6												
LM End	3.64	Issue Type +	Ob	Location *	LS												
Category	Earthen Levee			GPS Latitude/Longitude													
				Start	End												
Item	Slope Stability			38.454032 °	38.453680 °												
				-121.590025 °	-121.590173 °												
DWR ID	DWR_RD0999_01_s_2012_6																
Action/Comments																	
Repair slope instability. Inspector Comments: District Manager (Bob Webber) indicated that the area has a history of cracking and sloughing. District plans to repair site this summer. District repaired site without notifying the Dept. No compaction results provided. Unclear how site was repaired. Need more information about repair from district. During the fall inspection small cracks and sloughing were seen re-appearing on landside shoulder and slope.

Looking north at sloughing on landside shoulder and slope.

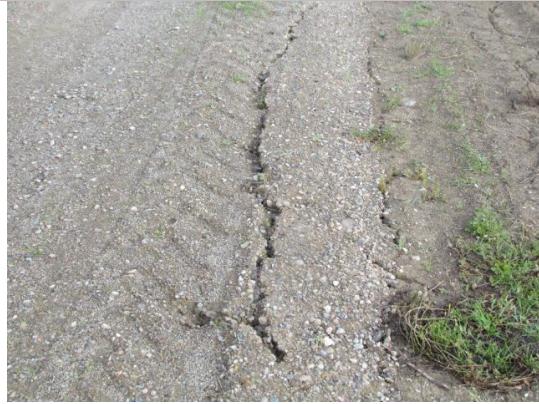
Photo 2 of 2 : FA_2015_RD0999_232_6_20150914_00014.jpg

Looking north at cracking and sloughing on landside shoulder and slope.

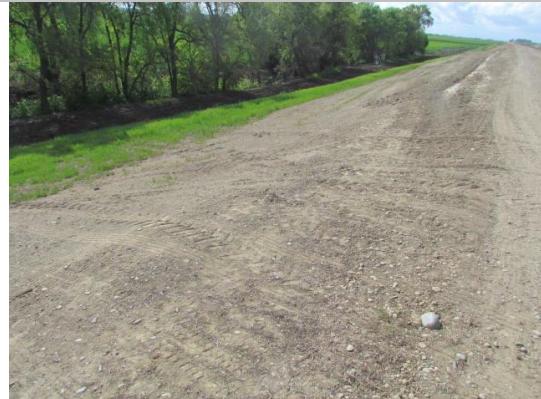
Photo 1 of 4 : FA_2015_RD0999_232_35_20150914_00042.jpg

LM Start	4.31	Rating **	M	Issue No.	35										
LM End	4.31	Issue Type +	Ma	Location *	LS										
Category	Earthen Levee			GPS Latitude/Longitude											
				Start	End										
Item	Slope Stability			38.444561 °	38.444561 °										
				-121.594438 °	-121.594438 °										
DWR ID	DWR_RD0999_01_f_2012_35														
Action/Comments															
Repair the levee slope damaged by vehicle traffic and prevent access where possible. Inspector Comments: Depression is caused by vehicle traffic.

Looking southeast at slope damage cause by vehicle traffic on landward slope. (Spring 2015)

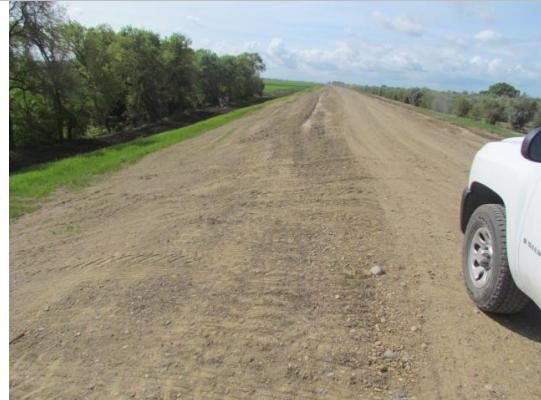
Photo 2 of 4 : FA_2015_RD0999_232_35_20150914_00043.jpg

Looking south at slope damage cause by vehicle traffic on landward slope. (Spring 2015)

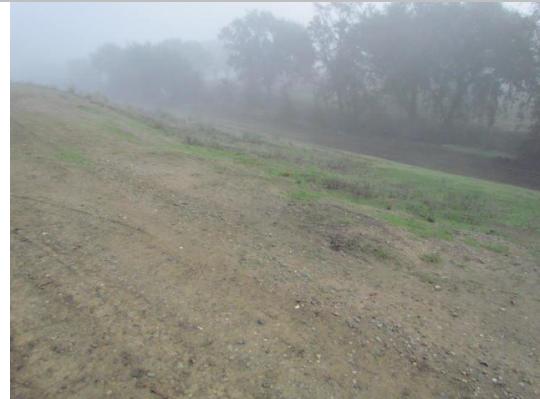
Photo 4 of 4 : FA_2015_RD0999_232_35_20150914_00045.jpg

Looking east at slope damage on landside slope.

LM Start	4.31	Rating **	M	Issue No.	35 (cont)										
LM End	4.31	Issue Type +	Ma	Location *	LS										
Category	Earthen Levee			GPS Latitude/Longitude											
				Start	End										
Item	Slope Stability			38.444561 °	38.444561 °										
				-121.594438 °	-121.594438 °										
DWR ID	DWR_RD0999_01_f_2012_35														
Action/Comments															
Repair the levee slope damaged by vehicle traffic and prevent access where possible. Inspector Comments: Depression is caused by vehicle traffic.

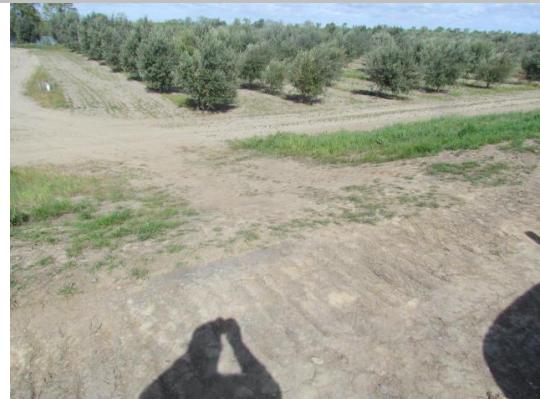
Photo 1 of 3 : FA_2015_RD0999_232_27_20150914_00030.jpg

LM Start	4.31	Rating **	M	Issue No.	27										
LM End	4.31	Issue Type +	Ma	Location *	WS										
Category	Earthen Levee			GPS Latitude/Longitude											
				Start	End										
Item	Slope Stability			38.444560 °	38.444560 °										
				-121.594440 °	-121.594440 °										
DWR ID	DWR_RD0999_01_f_2012_27														
Action/Comments															
Repair the levee slope damaged by vehicle traffic and prevent access where possible. Inspector Comments: Local farmer causing slope damage by driving equipment and trucks on slope.

Looking west at slope damage cause by vehicle traffic on waterward slope. (Spring 2015)

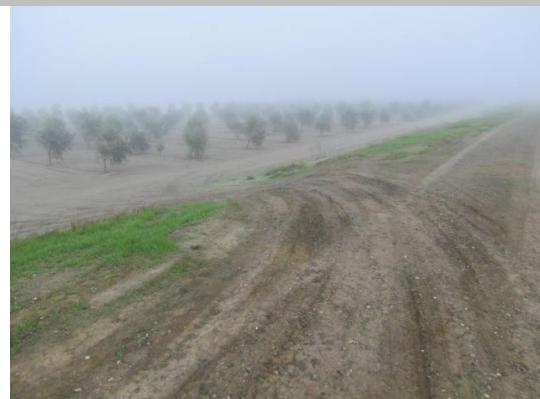
Photo 2 of 3 : FA_2015_RD0999_232_27_20150914_00031.jpg

Looking northwest at slope damage caused by vehicle traffic. (Fall 2014)

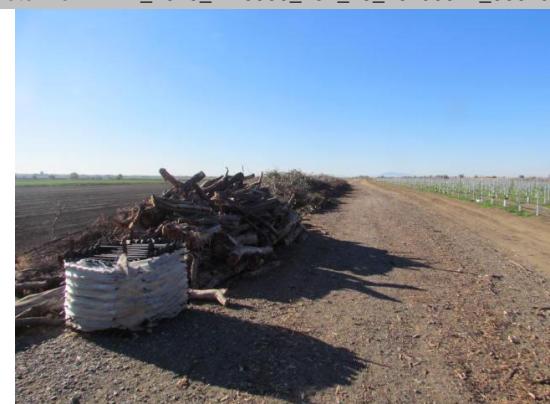
LM Start	6.53	Rating **	A/W	Issue No.	18		Photo 1 of 2 : FA_2015_RD0999_232_18_20150914_00019.jpg								
LM End	6.58	Issue Type +	Ma	Location *	LS										
Category	Earthen Levee			GPS Latitude/Longitude											
				Start	End										
Item	Encroachments			38.414367 °	38.413698 °	-121.608430 °	-121.608762 °								
DWR ID	DWR_RD0999_01_s_2012_18														
Action/Comments															
Prunings Inspector Comments: Large pruning piles on landward shoulder. Part of pruning pile blocking levee crown.

Looking south at pruning piles on landward shoulder. (Fall 2014)

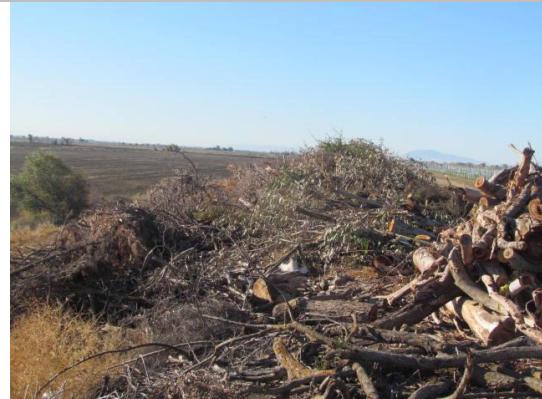
Photo 2 of 2 : FA_2015_RD0999_232_18_20150914_00020.jpg

LM Start	6.53	Rating **	A/W	Issue No.	18 (cont)							
LM End	6.58	Issue Type +	Ma	Location *	LS							
Category	Earthen Levee			GPS Latitude/Longitude								
				Start	End							
Item	Encroachments			38.414367 °	38.413698 °							
				-121.608430 °	-121.608762 °							
DWR ID	DWR_RD0999_01_s_2012_18											
Action/Comments												
Prunings Inspector Comments: Large pruning piles on landward shoulder. Part of pruning pile blocking levee crown.

Looking northwest at large pruning piles on landward shoulder and slope. (Fall 2014)

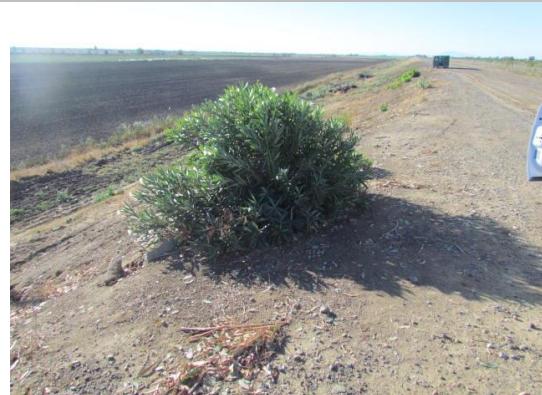
Photo 1 of 1 : FA_2015_RD0999_232_38_20151106_00088.jpg

LM Start	6.53	Rating **	M	Issue No.	38							
LM End	6.53	Issue Type +	Ma	Location *	LS							
Category	Earthen Levee			GPS Latitude/Longitude								
				Start	End							
Item	Vegetation			38.414332 °	38.414332 °							
				-121.608413 °	-121.608413 °							
DWR ID	DWR_RD0999_01_f_2015_38											
Action/Comments												
Remove the wild growth other than native grasses from the levee slopes. Inspector Comments: Remove young oleander from landward shoulder and slope.

Looking at oleander on landward shoulder.

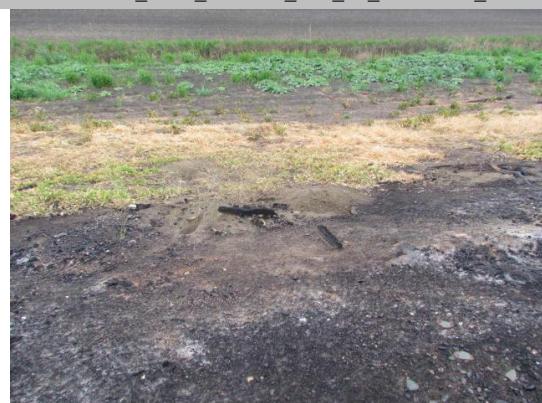
Photo 1 of 2 : FA_2015_RD0999_232_42_20150914_00052.jpg

LM Start	6.56	Rating **	M	Issue No.	42							
LM End	6.56	Issue Type +	Ma	Location *	LS							
Category	Earthen Levee			GPS Latitude/Longitude								
				Start	End							
Item	Animal Control			38.413858 °	38.413858 °							
				-121.608638 °	-121.608638 °							
DWR ID	DWR_RD0999_01_s_2012_42											
Action/Comments												
Exterminate rodents and backfill and compact or grout burrows. Inspector Comments: More than five holes within 25' of levee.

Looking east at rodent holes on landside slope.

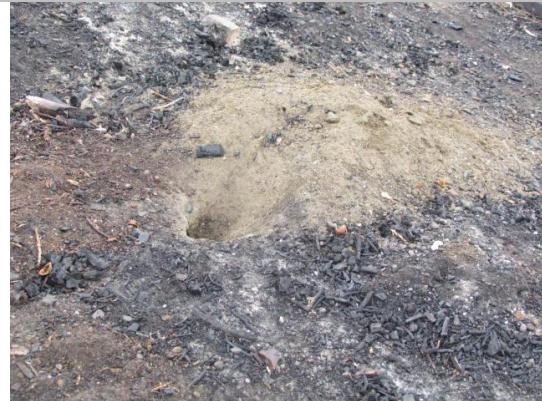
Photo 2 of 2 : FA_2015_RD0999_232_42_20150914_00053.jpg

LM Start	6.56	Rating **	M	Issue No.	42 (cont)															
LM End	6.56	Issue Type +	Ma	Location *	LS															
Category	Earthen Levee			GPS Latitude/Longitude																
				Start	End															
Item	Animal Control			38.413858 °	38.413858 °															
				-121.608638 °	-121.608638 °															
DWR ID	DWR_RD0999_01_s_2012_42																			
Action/Comments																				
Exterminate rodents and backfill and compact or grout burrows. Inspector Comments: More than five holes within 25' of levee.

Looking at typical rodent hole on landside slope.

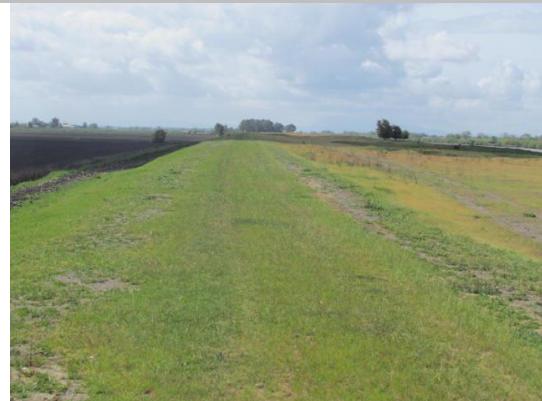
Photo 1 of 1 : FA_2015_RD0999_232_22_20150914_00025.jpg

LM Start	7.08	Rating **	M	Issue No.	22															
LM End	8.88	Issue Type +	Ma	Location *	CR															
Category	Earthen Levee			GPS Latitude/Longitude																
				Start	End															
Item	Crown Surface / Depressions / Rutting			38.406842 °	38.382338 °															
				-121.611897 °	-121.623343 °															
DWR ID	DWR_RD0999_01_s_2012_22																			
Action/Comments																				
Add appropriate gravel or road base. Grade and compact.

Looking south at levee crown. (Spring 2015)

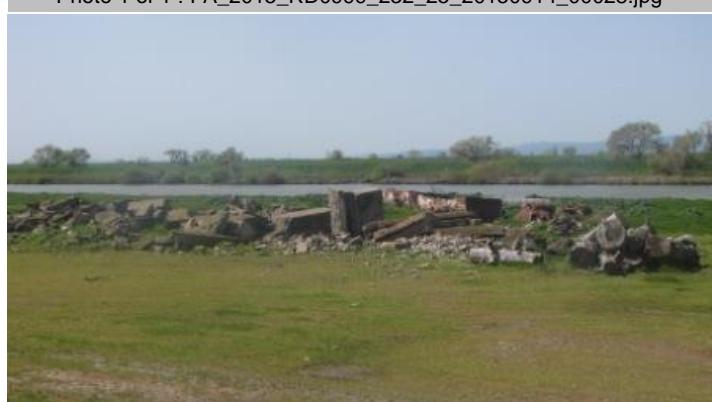
Photo 1 of 1 : FA_2015_RD0999_232_25_20150914_00028.jpg

LM Start	8.15	Rating **	M	Issue No.	25															
LM End	8.15	Issue Type +	Ma	Location *	WS															
Category	Earthen Levee			GPS Latitude/Longitude																
				Start	End															
Item	Encroachments			38.392255 °	38.392255 °															
				-121.618709 °	-121.618709 °															
DWR ID	DWR_RD0999_01_s_2012_25																			
Action/Comments																				
Material Inspector Comments: Concrete rubble on waterside berm.

Looking west at concrete rubble on waterside berm.

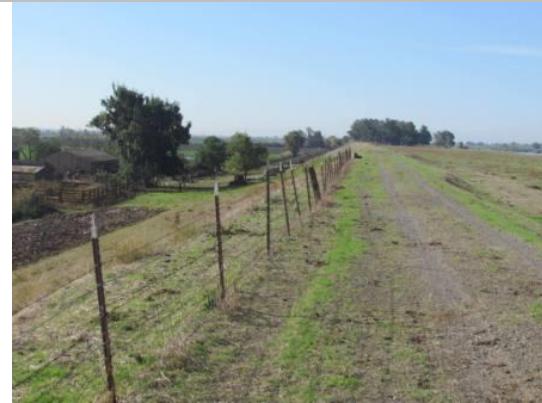
Photo 1 of 2 : FA_2015_RD0999_232_918_20150914_00077.jpg

LM Start	9.19	Rating **	M	Issue No.	918										
LM End	9.25	Issue Type +	En	Location *	LS										
Category	Earthen Levee		GPS Latitude/Longitude												
			Start	End											
Item	Encroachments		38.378161 °	38.377261 °											
			-121.625181 °	-121.625619 °											
DWR ID	DWR_RD0999_01_s_2012_918														
Action/Comments															
Fence Inspector Comments: Fence along landward shoulder.

Looking south at fence along landside shoulder.

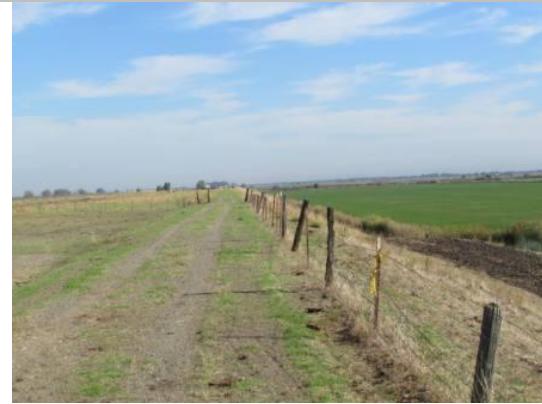
Photo 2 of 2 : FA_2015_RD0999_232_918_20150914_00078.jpg

Looking north at fence along landside shoulder.

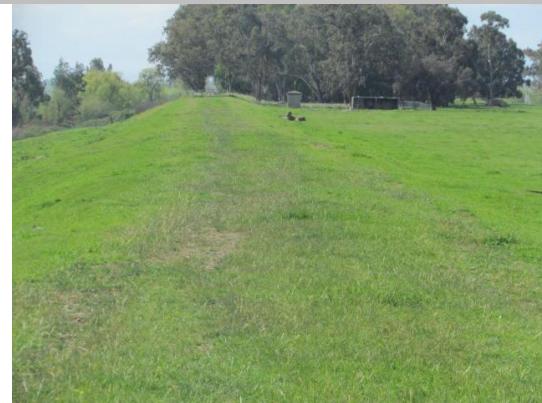
Photo 1 of 2 : FA_2015_RD0999_232_919_20150914_00079.jpg

LM Start	9.30	Rating **	M	Issue No.	919										
LM End	9.73	Issue Type +	Ma	Location *	CR										
Category	Earthen Levee		GPS Latitude/Longitude												
			Start	End											
Item	Crown Surface / Depressions / Rutting		38.376669 °	38.370762 °											
			-121.625896 °	-121.628640 °											
DWR ID	DWR_RD0999_01_s_2012_919														
Action/Comments															
Add appropriate material and re-grade the levee to bring the crown above the design elevation.

Looking south at levee crown. Spring 2015

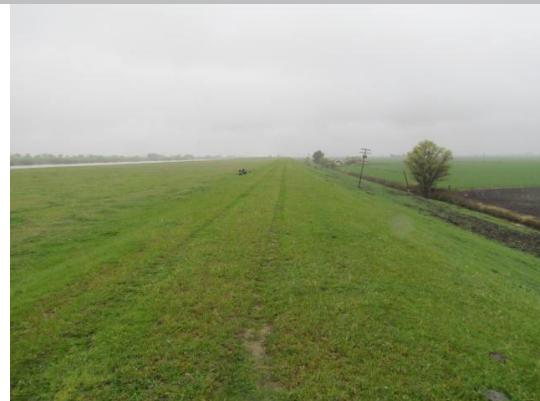
Photo 2 of 2 : FA_2015_RD0999_232_919_20150914_00080.jpg

LM Start	9.30	Rating **	M	Issue No.	919 (cont)									
LM End	9.73	Issue Type +	Ma	Location *	CR									
Category	Earthen Levee			GPS Latitude/Longitude										
				Start	End									
Item	Crown Surface / Depressions / Rutting		38.376669 °	38.370762 °										
			-121.625896 °	-121.628640 °										
DWR ID	DWR_RD0999_01_s_2012_919													
Action/Comments														
Add appropriate material and re-grade the levee to bring the crown above the design elevation.

Looking south at crown roadway. Spring 2014

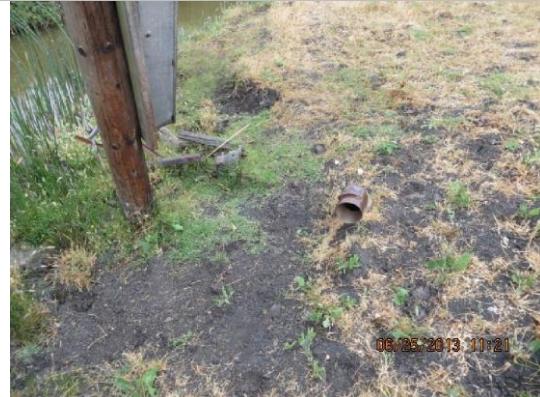
Photo 1 of 3 : UCIP_FA_2015_0596.jpg

LM Start	9.50	Rating **	M	Issue No.	923									
LM End	9.50	Issue Type +	En	Location *	CR									
Category	Supplemental			GPS Latitude/Longitude										
				Start	End									
Item	DWR UCIP Field Study		38.373823 °	38.373823 °										
			-121.627212 °	-121.627212 °										
DWR ID														
Action/Comments														
Inspector Comments: FS_ID:24413 DS_ID:22750 EP_NO: 13300 FS_HLM: 9.519 Repair Type: Non-Urgent Crossing Status: Found UCIP Comments: Pipe abandoned and should be done so properly. FIELD_STRUCT_DESC: 6-inch steel pipe through the levee 3.0 feet below the crown. JP and meter at abandoned pump location on LS toe (Permit No. 13300, 1983). FS Date: 06/25/2013

JP and meter at site of abandoned pump.

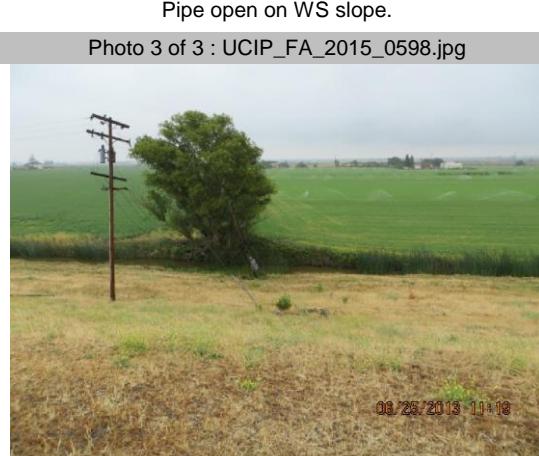
JP and meter at site of abandoned pump.

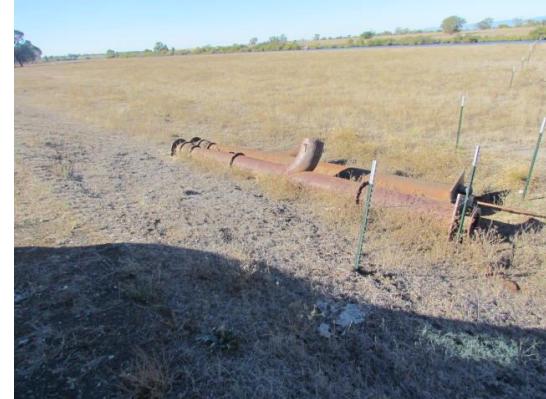
Photo 1 of 1 : FA_2015_RD0999_232_47_20151106_00089.jpg

LM Start	9.51	Rating **	M	Issue No.	47				
LM End	9.51	Issue Type +	Ma	Location *	WS				
Category	Earthen Levee			GPS Latitude/Longitude					
				Start	End				
Item	Encroachments			38.373740 °	38.373740 °				
				-121.627257 °	-121.627257 °				
DWR ID	DWR_RD0999_01_f_2015_47								
Action/Comments									
Pipe	Inspector Comments: Abandoned pipes at waterward toe.

Looking southwest at abandoned irrigation pipes at waterward toe.

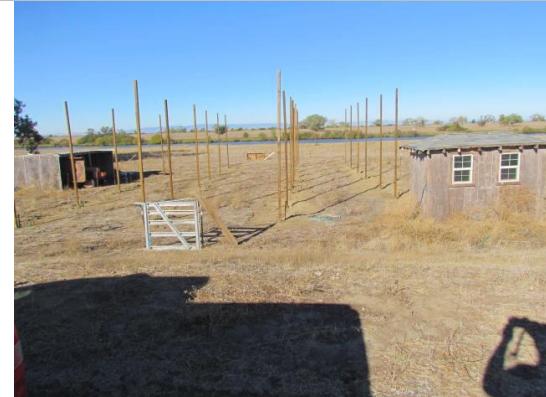
Photo 1 of 1 : FA_2015_RD0999_232_56_20151106_00090.jpg

LM Start	9.64	Rating **	M	Issue No.	56				
LM End	9.64	Issue Type +	En	Location *	WS				
Category	Earthen Levee			GPS Latitude/Longitude					
				Start	End				
Item	Encroachments			38.372002 °	38.372002 °				
				-121.628052 °	-121.628052 °				
DWR ID	DWR_RD0999_01_f_2015_56								
Action/Comments									
Crops	Inspector Comments: Landowner planted crops and installed poles and tool sheds on waterward berm without permit

Looking at west at crop, poles and tool sheds on waterward berm.

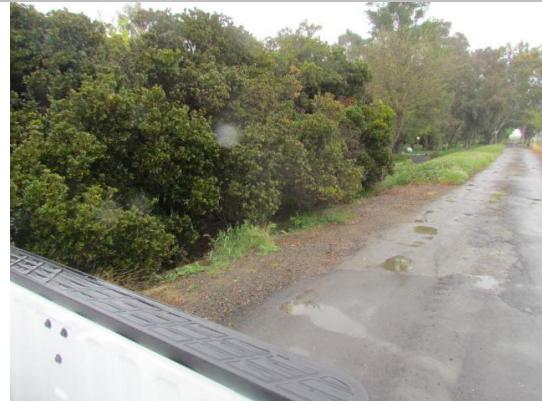
Photo 1 of 1 : FA_2015_RD0999_232_26_20150914_00029.jpg

LM Start	9.87	Rating **	M	Issue No.	26										
LM End	9.87	Issue Type +	En	Location *	WS										
Category	Earthen Levee			GPS Latitude/Longitude											
				Start	End										
Item	Vegetation			38.368898 °	38.368898 °										
				-121.629470 °	-121.629470 °										
DWR ID	DWR_RD0999_01_s_2012_26														
Action/Comments															
Landscaping Inspector Comments: Trees should be trimmed for visibility.

Looking northwest at dense trees on waterside slope.

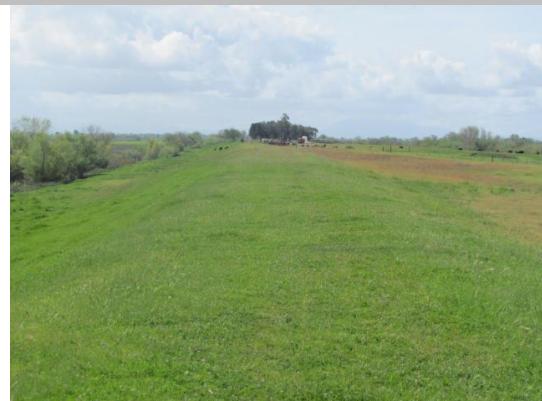
Photo 1 of 2 : FA_2015_RD0999_232_920_20150914_00081.jpg

LM Start	9.94	Rating **	M	Issue No.	920										
LM End	10.21	Issue Type +	Ma	Location *	CR										
Category	Earthen Levee			GPS Latitude/Longitude											
				Start	End										
Item	Crown Surface / Depressions / Rutting			38.367831 °	38.364238 °										
				-121.629990 °	-121.631674 °										
DWR ID	DWR_RD0999_01_s_2012_920														
Action/Comments															
Add appropriate material and re-grade the levee to bring the crown above the design elevation.

Looking south at levee crown. (Spring 2015)

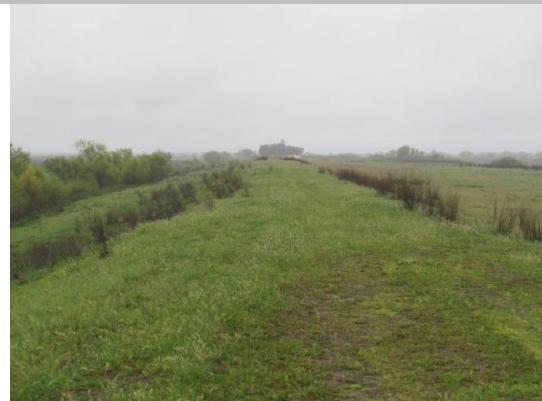
Photo 2 of 2 : FA_2015_RD0999_232_920_20150914_00082.jpg

Looking south at crown roadway. (Spring 2014)

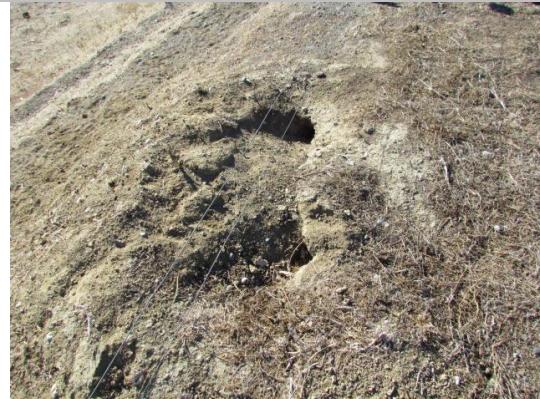
Photo 1 of 4 : FA_2015_RD0999_232_2_20151106_00091.jpg

LM Start	9.95	Rating **	U	Issue No.	2										
LM End	9.95	Issue Type +	Ma	Location *	LS										
Category	Earthen Levee		GPS Latitude/Longitude												
			Start	End											
Item	Animal Control		38.367750 °	38.367750 °											
			-121.630025 °	-121.630025 °											
DWR ID	DWR_RD0999_01_s_2012_2														
Action/Comments															
Exterminate rodents and backfill and compact or grout burrows. Inspector Comments: Several large rodent holes on landward shoulder.

Looking aouteast at rodent holes on landward shoulder fall 2015.

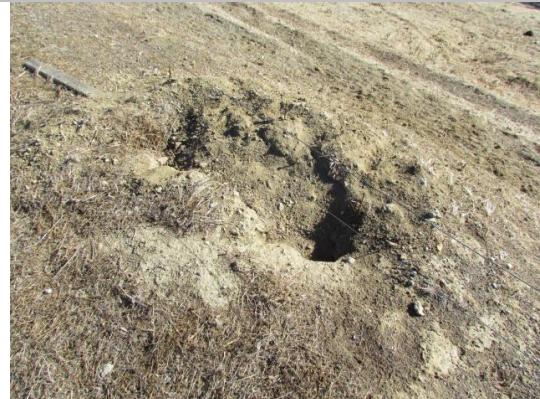
Photo 2 of 4 : FA_2015_RD0999_232_2_20151106_00092.jpg

Looking northeast at rodent holes on landward shoulder fall 2015.

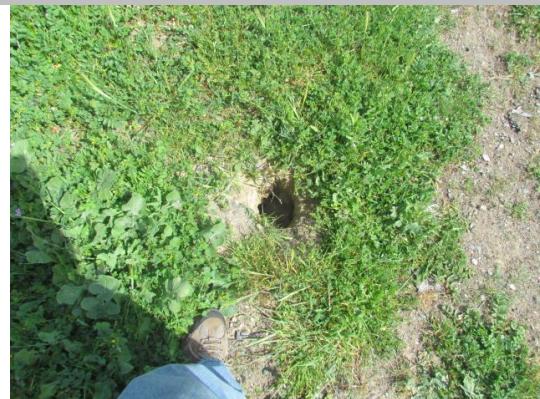
Photo 3 of 4 : FA_2015_RD0999_232_2_20150914_00006.jpg

Looking at typical rodent holes on landward shoulder. (Spring 2015)

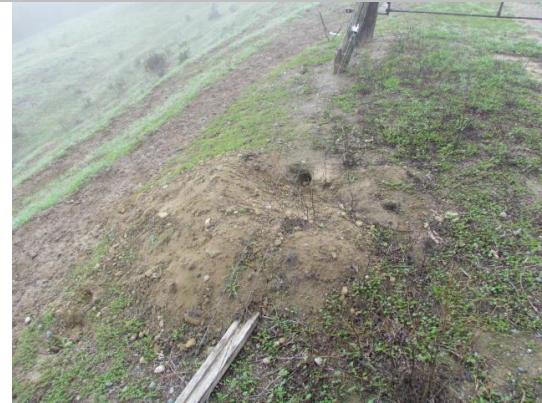
Photo 4 of 4 : FA_2015_RD0999_232_2_20150914_00007.jpg

LM Start	9.95	Rating **	U	Issue No.	2 (cont)												
LM End	9.95	Issue Type +	Ma	Location *	LS												
Category	Earthen Levee			GPS Latitude/Longitude													
				Start	End												
Item	Animal Control			38.367750 °	38.367750 °												
				-121.630025 °	-121.630025 °												
DWR ID	DWR_RD0999_01_s_2012_2																
Action/Comments																	
Exterminate rodents and backfill and compact or grout burrows. Inspector Comments: Several large rodent holes on landward shoulder.

Looking south at rodent hole on landside shoulder. (Fall 2014)

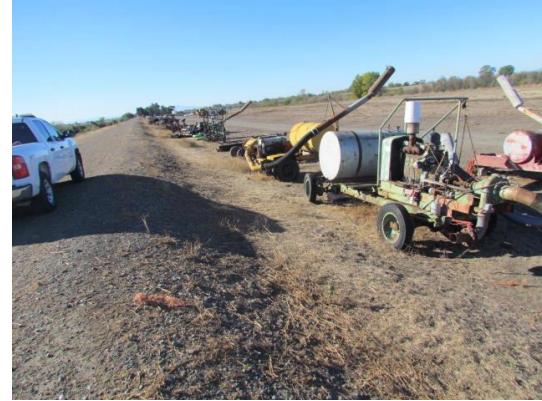
Photo 1 of 1 : FA_2015_RD0999_232_57_20151106_00093.jpg

LM Start	10.33	Rating **	M	Issue No.	57												
LM End	10.65	Issue Type +	En	Location *	WS												
Category	Earthen Levee			GPS Latitude/Longitude													
				Start	End												
Item	Encroachments			38.362528 °	38.358175 °												
				-121.632517 °	-121.634490 °												
DWR ID	DWR_RD0999_01_f_2015_57																
Action/Comments																	
Equipment Inspector Comments: Farm equipment stored at waterward toe.

Looking southwest at farm equipment stored at waterward berm.

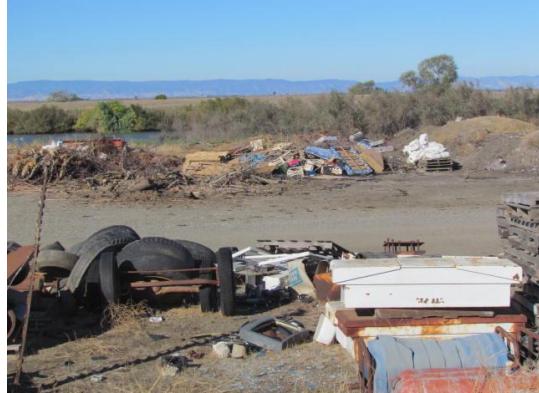
Photo 1 of 2 : FA_2015_RD0999_232_28_20151106_00094.jpg

LM Start	10.57	Rating **	M	Issue No.	28													
LM End	10.57	Issue Type +	En	Location *	WS													
Category	Earthen Levee			GPS Latitude/Longitude														
				Start	End													
Item	Encroachments			38.359305 °	38.359305 °													
				-121.633949 °	-121.633949 °													
DWR ID	DWR_RD0999_01_s_2012_28																	
Action/Comments																		
Garbage Inspector Comments: Large garbage and pruning piles on waterward berm.

Looking west at garbage pile on waterward berm fall 2015.

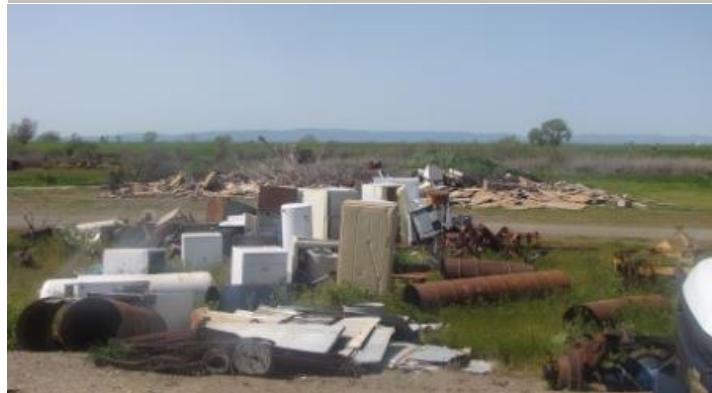
Photo 2 of 2 : FA_2015_RD0999_232_28_20150914_00033.jpg

Looking southwest at garbage on waterside toe and berm.

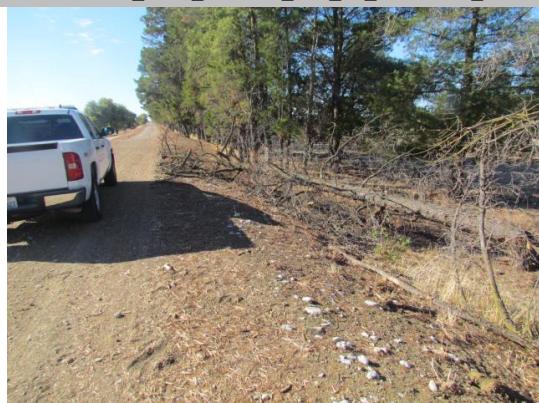
Photo 1 of 1 : FA_2015_RD0999_232_61_20150914_00070.jpg

LM Start	10.75	Rating **	A/W	Issue No.	61													
LM End	10.75	Issue Type +	Ma	Location *	WS													
Category	Earthen Levee			GPS Latitude/Longitude														
				Start	End													
Item	Encroachments			38.356844 °	38.356844 °													
				-121.635101 °	-121.635101 °													
DWR ID	DWR_RD0999_01_f_2014_61																	
Action/Comments																		
Tree or limb Inspector Comments: Downed tree on waterward slope has been removed, but should be monitored.

Looking southwest at downed tree on waterward slope.

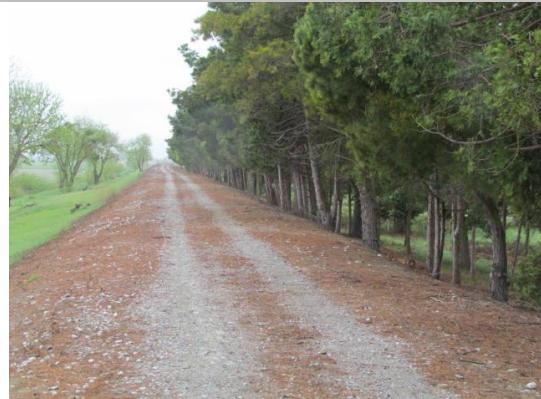
Photo 1 of 2 : FA_2015_RD0999_232_23_20150914_00026.jpg

LM Start	10.81	Rating **	A/W	Issue No.	23										
LM End	11.06	Issue Type +	Ma	Location *	WS										
Category	Earthen Levee			GPS Latitude/Longitude											
				Start	End										
Item	Trim / Thin Trees			38.356077 °	38.352640 °										
				-121.635598 °	-121.637078 °										
DWR ID	DWR_RD0999_01_s_2012_23														
Action/Comments															
Trim trees to at least five feet above ground level.

Looking south at trimmed pine trees on waterside shoulder and slope.
(Spring 2012)

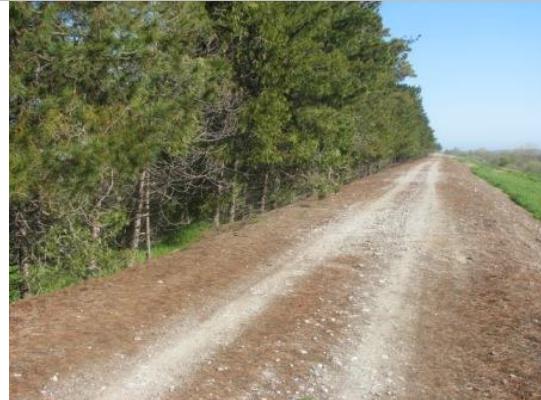
Photo 2 of 2 : FA_2015_RD0999_232_23_20150914_00027.jpg

LM Start	10.81	Rating **	A/W	Issue No.	23 (cont)	
LM End	11.06	Issue Type +	Ma	Location *	WS

Pine trees along waterside shoulder & slope. (Site of a old christmas tree farm). (Spring 2011)

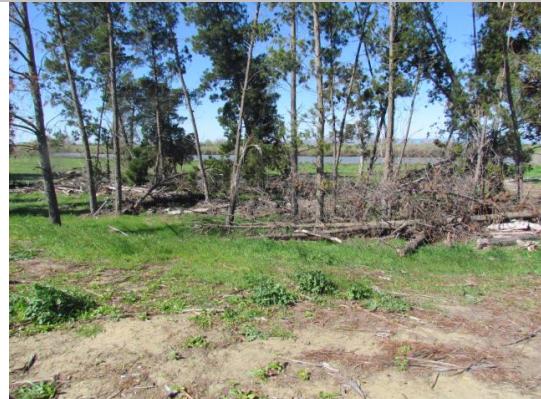
Photo 1 of 1 : FA_2015_RD0999_232_67_20150914_00076.jpg

LM Start	11.07	Rating **	M	Issue No.	67							
LM End	11.07	Issue Type +	En	Location *	WS							
Category	Earthen Levee			GPS Latitude/Longitude								
				Start	End							
Item	Encroachments			38.352552 °	38.352552 °							
				-121.637089 °	-121.637089 °							
DWR ID	DWR_RD0999_01_s_2014_67											
Action/Comments												
Prunings

Looking west at pruning piles on waterward berm.

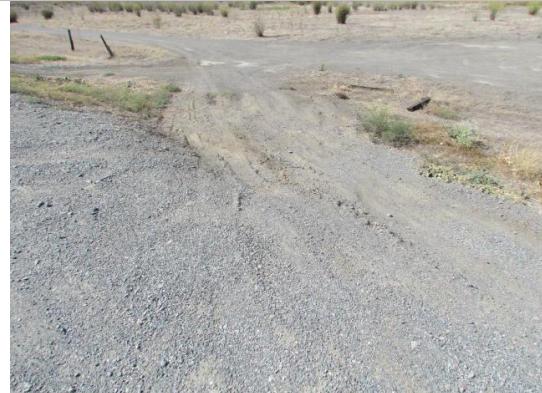
Photo 1 of 2 : FA_2015_RD0999_232_48_20150914_00059.jpg

LM Start	11.84	Rating **	M	Issue No.	48							
LM End	11.84	Issue Type +	Ma	Location *	WS							
Category	Earthen Levee		GPS Latitude/Longitude									
			Start	End								
Item	Slope Stability		38.342068 °	38.342068 °	-121.641944 °	-121.641944 °						
DWR ID	DWR_RD0999_01_f_2012_48											
Action/Comments												
Repair the levee slope damaged by vehicle traffic and prevent access where possible. Inspector Comments: Slope damage caused by vehicle traffic.

Looking southwest at slope damage caused by vehicle traffic. 2013

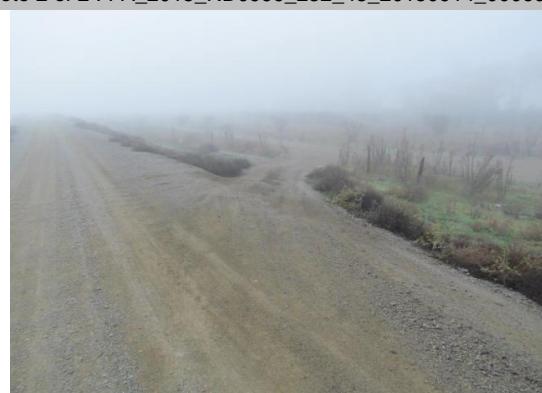
Photo 2 of 2 : FA_2015_RD0999_232_48_20150914_00060.jpg

Looking southwest at slope damage caused by vehicle traffic on waterside slope.

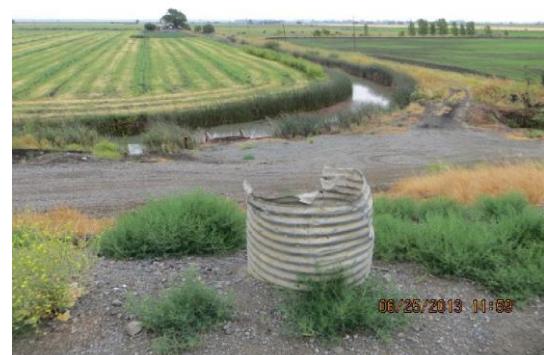
Photo 1 of 2 : UCIP_FA_2015_1008.jpg

Item	DWR UCIP Field Study			38.335834 °	38.335834 °													
				-121.643977 °	-121.643977 °													
DWR ID																		
Action/Comments																		
Inspector Comments: FS_ID:41785 DS_ID:22752 EP_NO: 11735 FS_HLM: 12.293 Repair Type: Urgent Crossing Status: Found UCIP Comments: Appears abandoned. Pipe exposed in cut on on WS slope and open at LS toe. No pump or appurtenances. FIELD_STRUCT_DESC: 24-inch steel pipe through the levee 7.0 feet below the crown. Pump in drain ditch on the landward side with a sheetpile headwall. Flap gate on the waterward end. Siphon breaker in riser on the landward slope (Permit No. 11735, 1978). Replaced an existing pipe. FS Date: 06/25/2013

Siphon breaker in CMP riser on LS shoulder.
